Manhole Inspection Summary

Manhole # S61S__003MH

Insp Date: **11/24/08 2:06 PM**

Location Address: **1600 Ponca St.**

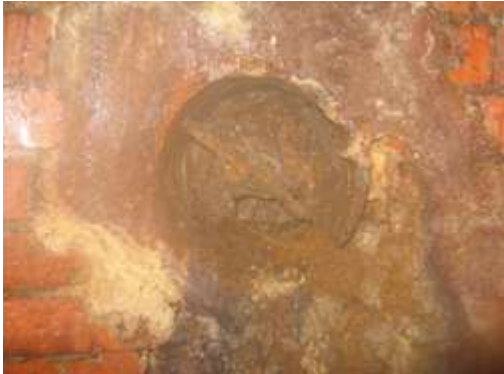
Old plugged service line

old line plugged. Encrustation around old plugged line

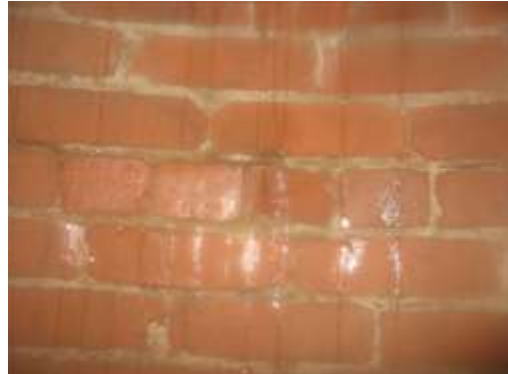
Defect 1

Leaking walls from mortar and joint.

Comments **CITY OPENED MANHOLE. 7/21/08. INSPECTED 11/24/2008. MANHOLE WALL SUGGEST A LINER TO STOP INFILTRATION. MAP SHOWS O12 IS 30". INSPECTION MEASURED IT AT 27".**

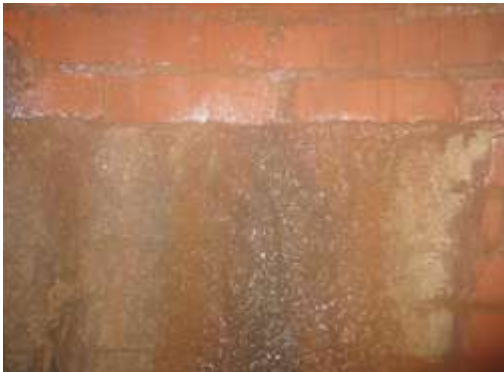
Defect 4

walls leaking

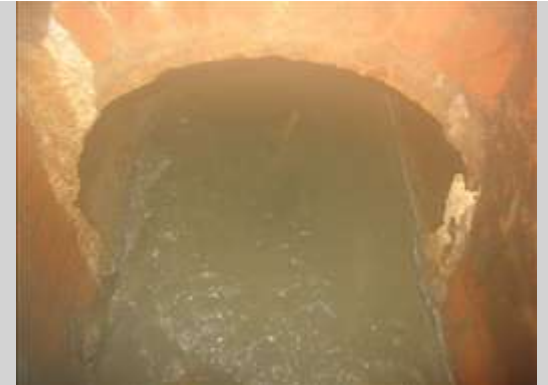
12 O'Clock Outflow

27 in. Circular Gravity Sewer
Pipe Out @ 12 O'Clock

Pipe Height: **27.6** (in.) Rod and Bar (Angled)
Pipe Material: **Clay** ☐ Pipe Lined
Invert Depth: **18.75** (ft.) Flow Characteristics: **Slow**
Deposits: ☐ None ☐ Mud ☐ Sludge ☒ **Debris** ☐ Grease
Silt Depth: **0.25** (in.) Deposits Extent: **Light**
Infiltration: **None** Pipe Seal Cond: **Sound**

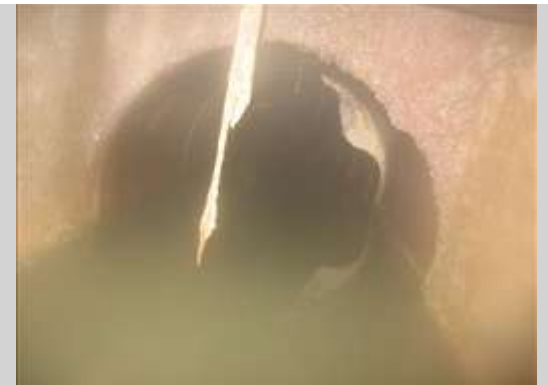
6 O'Clock Inflow

27 in. Circular Gravity Sewer
Pipe In @ 6 O'Clock

Pipe Height: **27.6** (in.) Rod and Bar (Angled)
Pipe Material: **Clay** ☐ Pipe Lined
Invert Depth: **18.58** (ft.) Flow Characteristics: **Slow**
Deposits: ☐ None ☐ Mud ☐ Sludge ☒ **Debris** ☐ Grease
Silt Depth: **0.25** (in.) Deposits Extent: **Light**
Infiltration: **None** Pipe Seal Cond: **Sound**

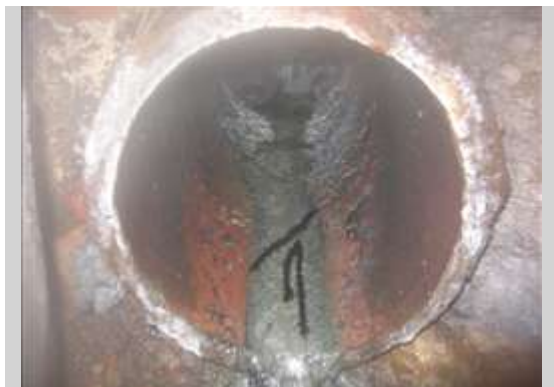
10 O'Clock Inflow

8 in. Circular Gravity Sewer

Pipe In @ 10 O'Clock
